Mass Wasting and Sediment Storage in a Small Montane Watershed: an Extreme Case of Anthropogenic Disturbance in the Humid Tropics

Matthew C. Larsen¹ and Abigail Santiago Román²

¹*U.S. Geological Survey, Guaynabo, Puerto Rico, USA*

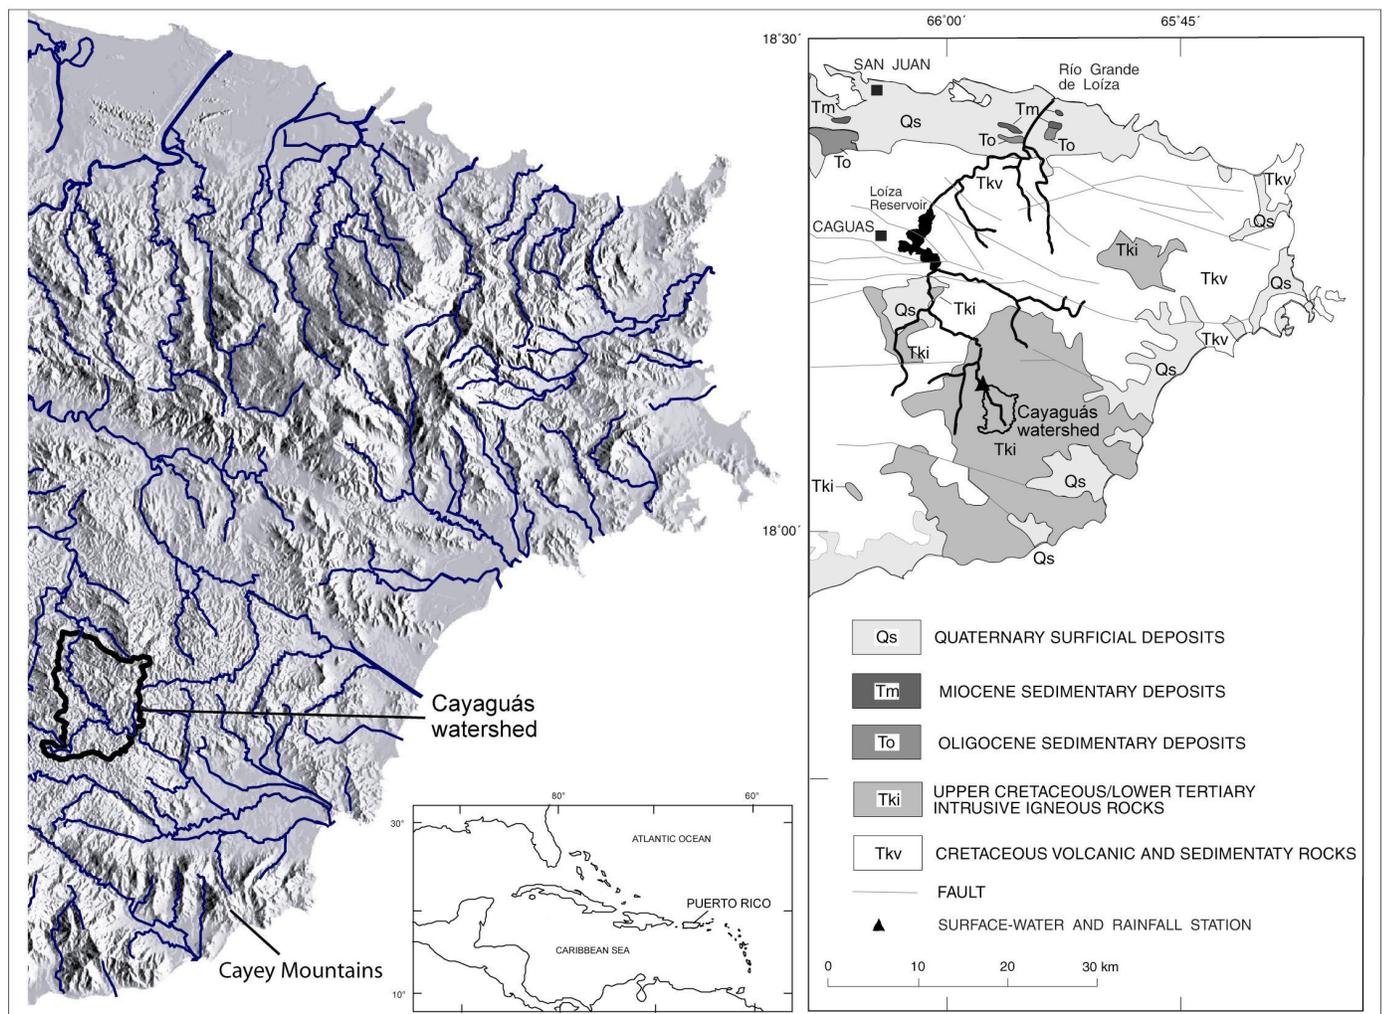
Figure 1. Shaded relief and simplified geology of eastern Puerto Rico showing location of the Cayaguás watershed (geology modified from Monroe, 1980).

The Cayaguás watershed (26.4 km²) is in southeastern Puerto Rico, about 35 km south of San Juan (Fig. 1). The watershed drains to the north and is bordered on the south by the Cayey Mountains. The climate is humid tropical with a mean annual rainfall of 1,930 mm and a mean annual temperature of 25°C [U.S. Department of Commerce, 1999]. Hillslopes are steep in the watershed; the mean slope is 19% (10.8°) and total relief is 293 m (Table 1). The average (map) channel gradient of the Cayaguás river is 12% (6.8°). The Cayaguás watershed is a tributary to the Río Grande de Loíza, which has the largest drainage basin in Puerto Rico, and flows into the Loíza Reservoir (Fig. 1). Constructed in 1953, this 267-ha impoundment supplies about 50% of public water to the 1.6 million inhabitants of metropolitan San Juan. Bathymetric surveys completed in 1994 indicate that sediment infilling of the reservoir, discussed below, had eliminated 47% of the original capacity [Webb and Soler-López, 1997].

Although large corestones are abundant on many hillslopes and in some channel reaches, most material delivered to drainage channels is sand sized ($D_{50} = 0.6$ mm)[Larsen, 1997]. Consequently, fluvial erosion and transport has been efficient at the millennial to geologic time scale, enhancing channel extension, as manifested by high drainage density seen on topographic maps of the area (Table 1). Modern evidence can be seen in active slumping at the heads of tributaries of some zero-order valleys. In addition to extension, widening of main channel valleys results from mass wasting on valley sides. Headward extension of these has enabled the stream system to approach within 12 km of the south (Caribbean) coast of the island, in spite of being part of a north coast draining river that crosses a straight-line distance of more than 50 km to reach the Atlantic Ocean (Fig. 1).

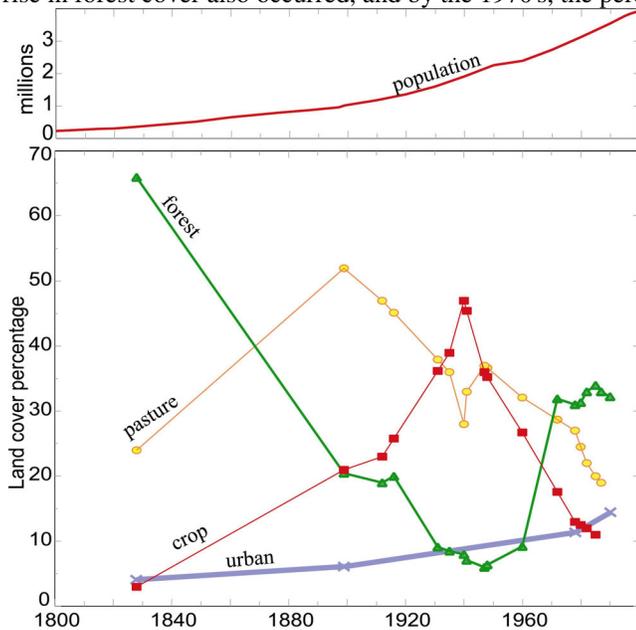
Figure 2. Generalized 19th-20th century land-use classification and population for Puerto Rico (land-use data from Alberts, 1940; Wadsworth, 1950; Birdsey and Weaver, 1987; Franco et al., 1997).

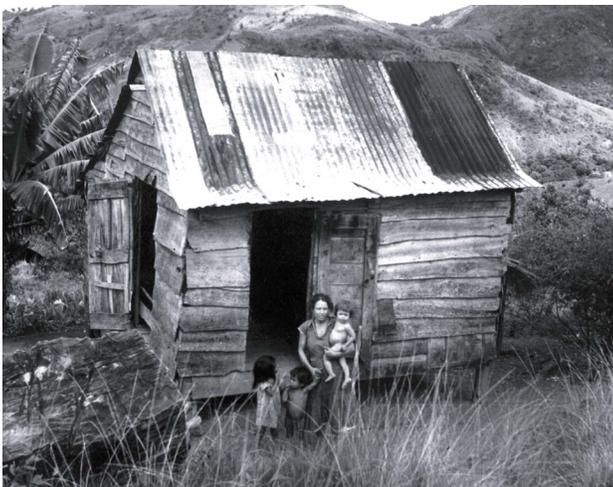
Figure 3 . Rural family and residence, 1940's, eastern Puerto Rico, with deforested hillslopes in background. (Photograph taken by F.H. Wadsworth, International Institute of Tropical Forestry, U.S. Forest Service, Río Piedras, Puerto Rico).

Landscape conversion in the Cayaguás watershed was carried to an extreme by 19th- and early 20th-century subsistence farmers who had removed at least 88% of the forest cover by 1937 (Fig. 3). It is probable that the farmers had eliminated even more forest cover prior to 1937, but aerial photographic documentation is not available. The removal of forest cover and subsequent intense year-round agriculture seems to have greatly accelerated hillslope erosion, as noted in other areas where human landscape disturbance is followed by very high erosion rates, at least immediately after the disturbance [Montgomery *et al.*, 2000]. The nearby Iacos watershed, which is located in the Luquillo Experimental Forest and consists of primary forest with comparable bedrock geology (quartz diorite)

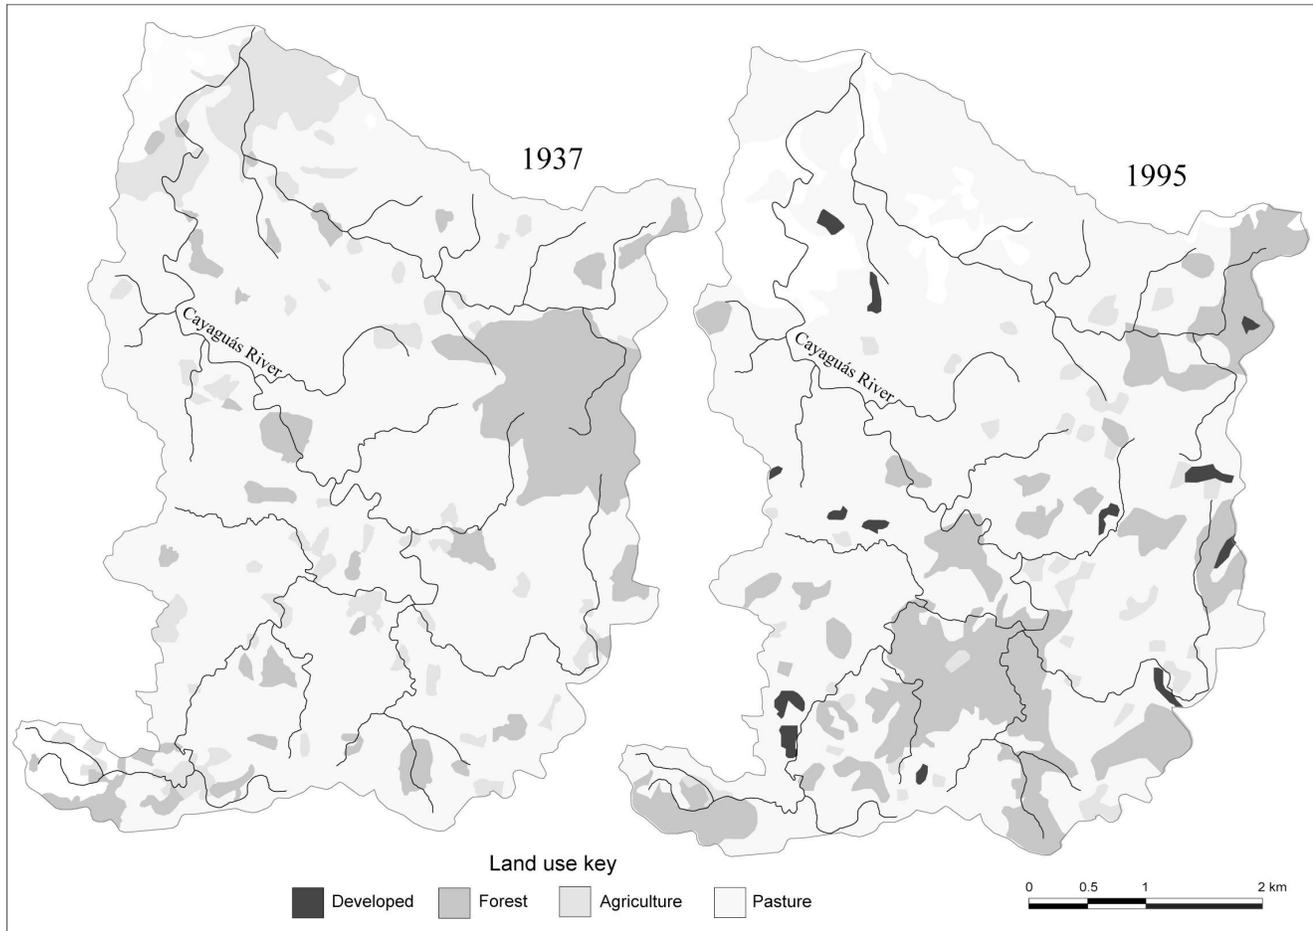
Figure 4 Generalized land use for 1937 and 1995 classified from black and white aerial photography, Cayaguás watershed, Puerto Rico.

Land-use characterization based on aerial photography indicates that by 1937, pasture was the dominant land cover for 84% of the surface area of the Cayaguás watershed (Fig. 4). Forest cover accounted for 12% of the area and the remainder was in crop and farm houses. Recent work indicates that as cultivated areas are abandoned, the land typically has reverted to pasture [Aide *et al.*, 1995]. This serves as a transitional, or buffer state, as it may be easily returned to cultivation after remaining fallow for several years. Alternatively, if cattle are kept off the land, secondary forest has been shown to recover in similar watersheds in Puerto Rico within about 20 years [Aide *et al.*, 1995]. Land-use practices in the watershed during the latter half of the 20th century diverged from the island average as pasture continued to be the primary land use at 66% of land cover in the Cayaguás watershed in 1995. This compares to pasture land cover of less than 19% for the island overall in 1987 (Fig. 2). During the second half of the 20th century, cropped areas decreased while forest cover and clusters of rural housing increased. Forest cover in 1937 was about 12% and decreased to less than 5% by 1950 [Brockman, 1952]. Forest recovery to 23% of the Cayaguás watershed had occurred by 1995.

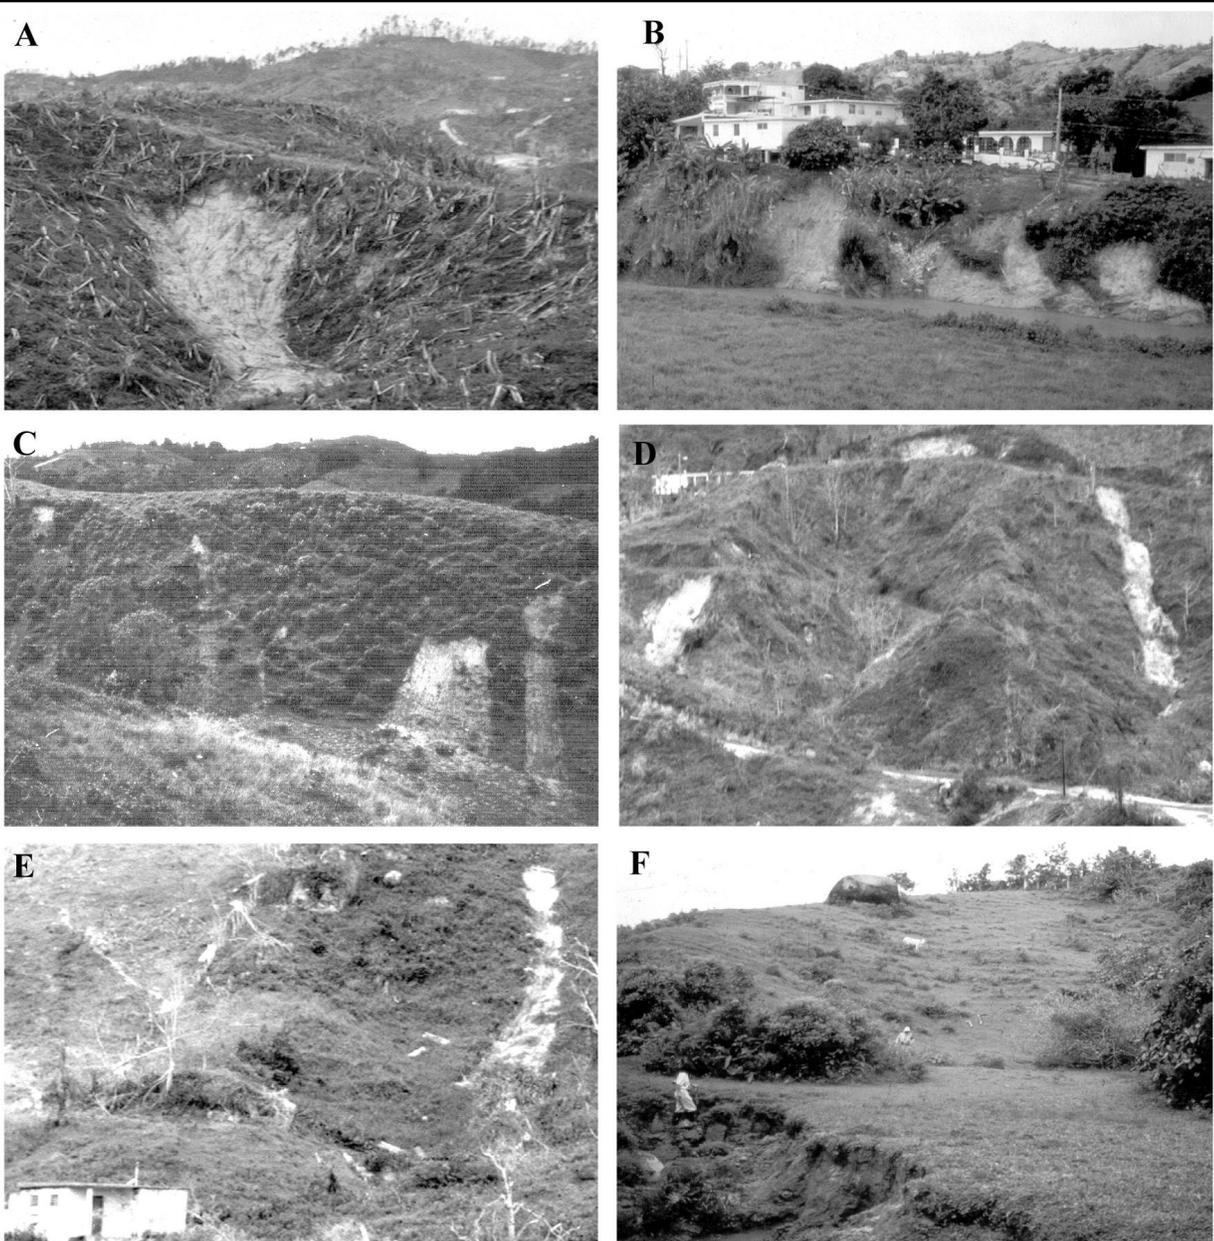
Figure 5. Views of landslide scars and stream channel headcutting associated with Hurricanes Hortense (September 1996) and Georges (September 1998) in the Cayaguás watershed, Puerto Rico. (A) Soil slip, 10 m long, on hillslope plantain field, September 1998. (B) Soils slips along Cayaguás tributary, September 1996. (C) Soil slips, 20 to 30 m long, September 1996. (D) Soil slip/debris flows, 10 and 30 m long, September 1998. Note larger deep landslide scar between the two recent ones. (E) Soil slip/debris flow, September 1998. (F) Headcut of first-order stream in colluvium at base of hillslope. Note large granodiorite corestone on ridgetop.

Most landslide scars mapped from aerial photographs predate the earliest available photographs (1937) and oral histories of local residents. Seventy percent of landslides mapped from 1951 and 1995 aerial photographs were present on the 1937 photographs. It is likely that accelerated rates of landsliding began in the early 19th century with the onset of forest clearing for agriculture. The causative storm events for landslide scars are therefore difficult to ascertain. The greatest rainfall intensities and widest distribution of storm rainfall in Puerto Rico usually are associated with tropical disturbances, which comprised 61% of the landslide-triggering storms recorded in the central mountains of Puerto Rico between 1960 and 1990 [Larsen and Simon, 1993]. Major hurricanes crossed the island in 1867, 1899, 1928, 1932, and 1960. These storms delivered precipitation totals of 300 to 800 mm in a 1 to 3 day period, and are the likely type of storm rainfall that triggered many of the landslide scars visible in the aerial photographs [Scatena and Larsen, 1991]. Conversations with watershed residents confirm that rainfall associated with hurricanes is commonly the trigger for landslides. This relation was observed following Hurricane Hortense (September 1996) and Hurricane Georges (September 1998) when dozens of debris flows, many extending from ridge top to the stream channel, were observed throughout the watershed (Fig. 5) [Torres-Sierra, 1997]. The rainfall totals from these two hurricanes had recurrence of intervals of 5 to 10 years in the Cayaguás watershed. The influx of landslide-derived and other sediment into channels resulted in 1.3 m of aggradation of the Cayaguás channel bed at the gage outlet following Hurricane Hortense [Larsen, 1997]. The channel bed surface was sustained at this elevation for three years before gradual degradation began in late 1999.

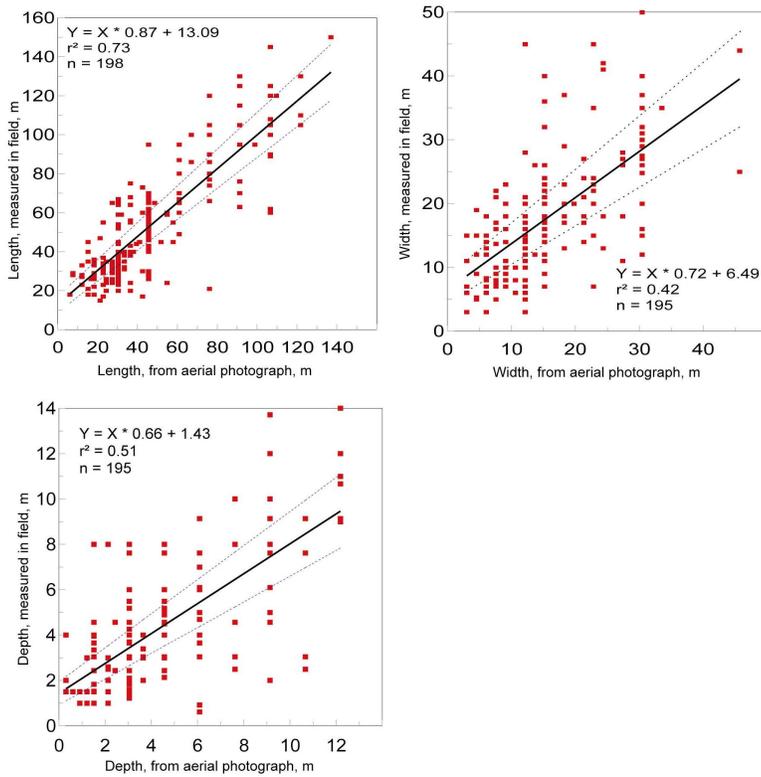
Figure 6. Relation between length, width, and depth of landslide scars measured in the field and measurements estimated from 1:20,000-scale aerial photographs, Cayaguás watershed. Simple linear regression models predict actual landslide scar dimension from that estimated using aerial photographs. Dashed lines show 95 percent confidence interval.

Landslide scar dimensions estimated from aerial photographs compared reasonably well to measurements made on the ground for length, but not as well for width and depth (Fig. 6). This result was expected as landslide scar length is relatively easy to determine while width and depth are more subjective, both from aerial photographs, as well as on the ground. The majority of scars have been modified by processes such as slopewash, trampling by cattle, plowing, and additional slumping on the side and head scarps [Trimble and Mendel, 1995; Larsen *et al.*, 1999]. This results in rounded head and side scarps and irregular scar depths that prevent precise measurements on the ground, as well as from the air (Fig. 7). The area, volume, and eroded mass of landslide scars discussed below are, therefore, approximations. The length, width, and depth of landslide scars measured on aerial photographs were adjusted using the equations shown in Figure 6.

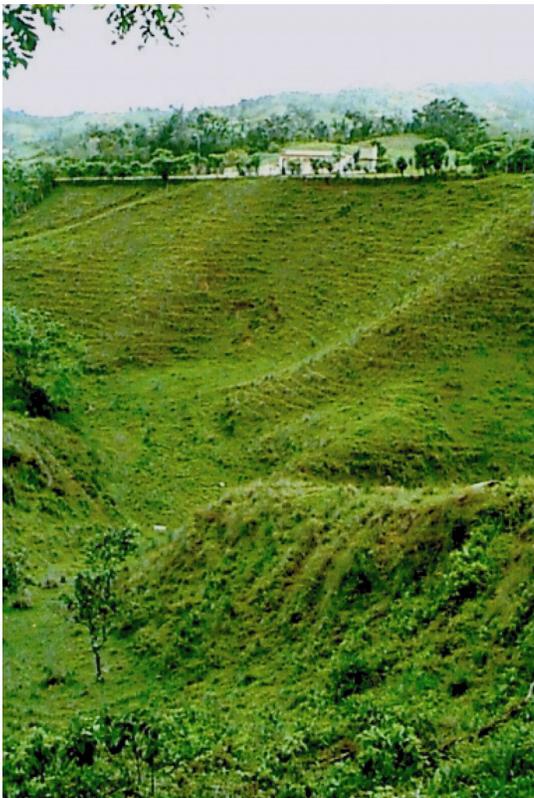
Figure 7. Amphitheater-shaped landslide scars and cow terracettes (created by cattle moving on preferred paths parallel to the slope contour), Cayaguás watershed. Landslide scar morphology is subdued because of past agricultural activity and grazing. Much of the soil and saprolite eroded by the mass wasting in this watershed remains in storage in deposits 3 meters thick on footslopes and small (zero-order) valley bottoms such as that shown here.

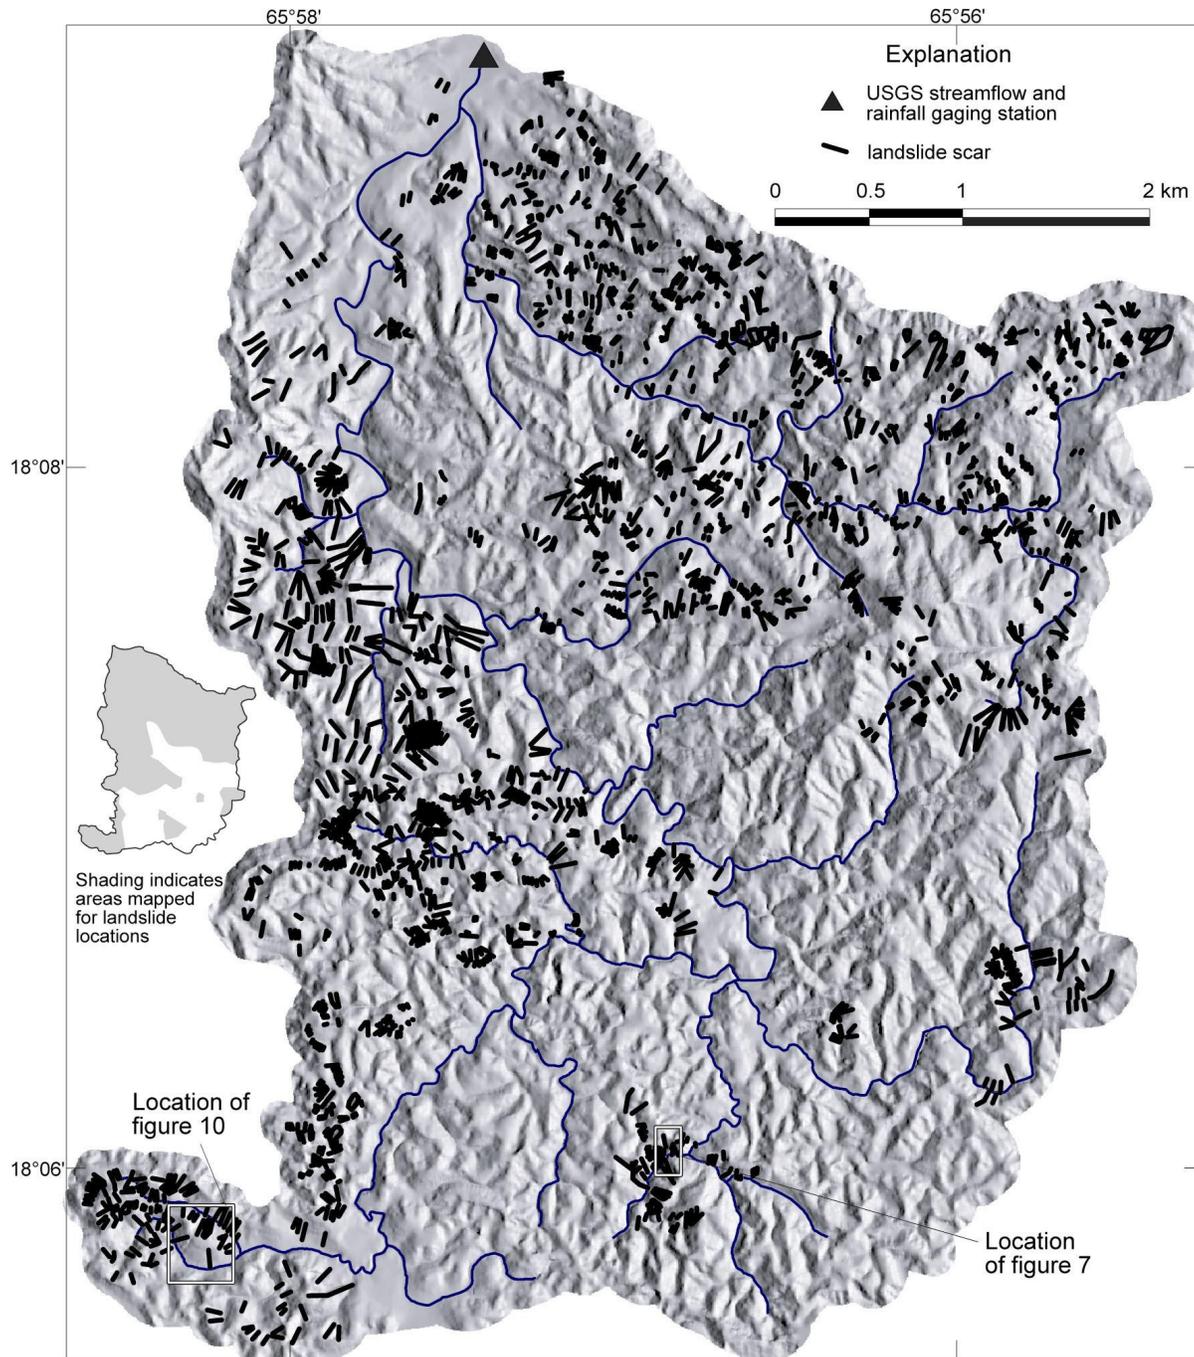
Figure 8. Shaded relief map of the Cayaguás watershed showing the location of 2,321 landslide scars mapped in a 16.6 square kilometer area (inset map shows area in which landslide scars were mapped) from 1937, 1951, and 1995 aerial photographs.

Landslide frequency was 140 scars/km², which, for an estimated period of about 175 years, equals 80 landslides per km²/100 y (Fig. 8). Mean soil density was determined to be 1.32 Mg/m³. This value exceeds that measured in nearby undisturbed forest where the effects of compaction from grazing and agriculture are absent and also reflects the abundance of dense clay [Larsen, 1997; Larsen et al., 1999; Simon et al., 1990]. The combined total surface area of all landslide scars was 2.27 million m² and the total mass equaled 14.4 million Mg (Table 3). Normalized to the watershed area, these values equal 140,000 m²/km² and 870,000 Mg/km², respectively.

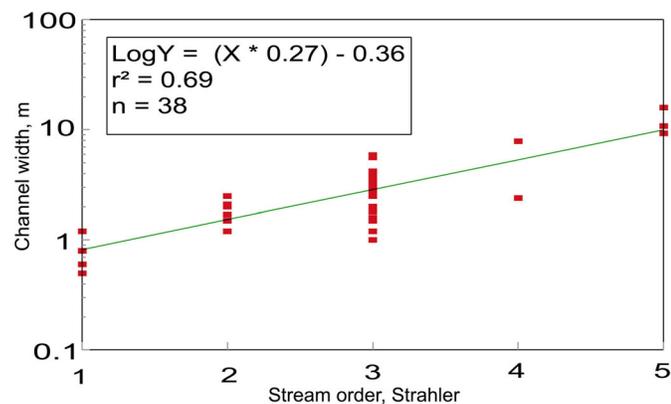
Figure 9. Relation between channel width and Strahler stream order in the Cayaguás watershed.

Channel widths were measured at 38 locations in the watershed and showed a pattern typical of fluvial systems where the increase in width with stream order defines a linear trend in semi-log space (Fig. 9; Tables 5,6). A total of 1.6 km of stream channel was surveyed to measure the dimensions of channel bars (Table 5). This length of channel represents a channel surface area of 14,500 m². Mean channel bar thickness was 0.12 m and, using a mean density of 1.14 Mg/m³ measured for sand bar deposits, the mean bar mass was 21 kg/m² of channel. A total of 5,300 Mg of sediment was calculated to be in active storage in channel bars (Table 6). Sediment in the other active compartment, the channel bed, was calculated to be 216,000 Mg. Using a 1.5-m mean thickness of alluvium and 3 m of colluvium thickness, the quantity of sediment stored in floodplains was estimated to be 1.79 million Mg; colluvial storage was about double this at 3.94 million Mg (Table 7). These two compartments are defined as semiactive. Inactive sediment, defined as that stored in approximately 4-m thick deposits of Quaternary alluvium, was calculated to be 0.68 million Mg. These data indicate that only a small portion of watershed sediment, 3.3%, exists in active storage compartments (Table 8). The majority of sediment, 87%, is in the semiactive compartments (i.e., floodplains and colluvium). The remainder, about 10%, is in Quaternary alluvium.

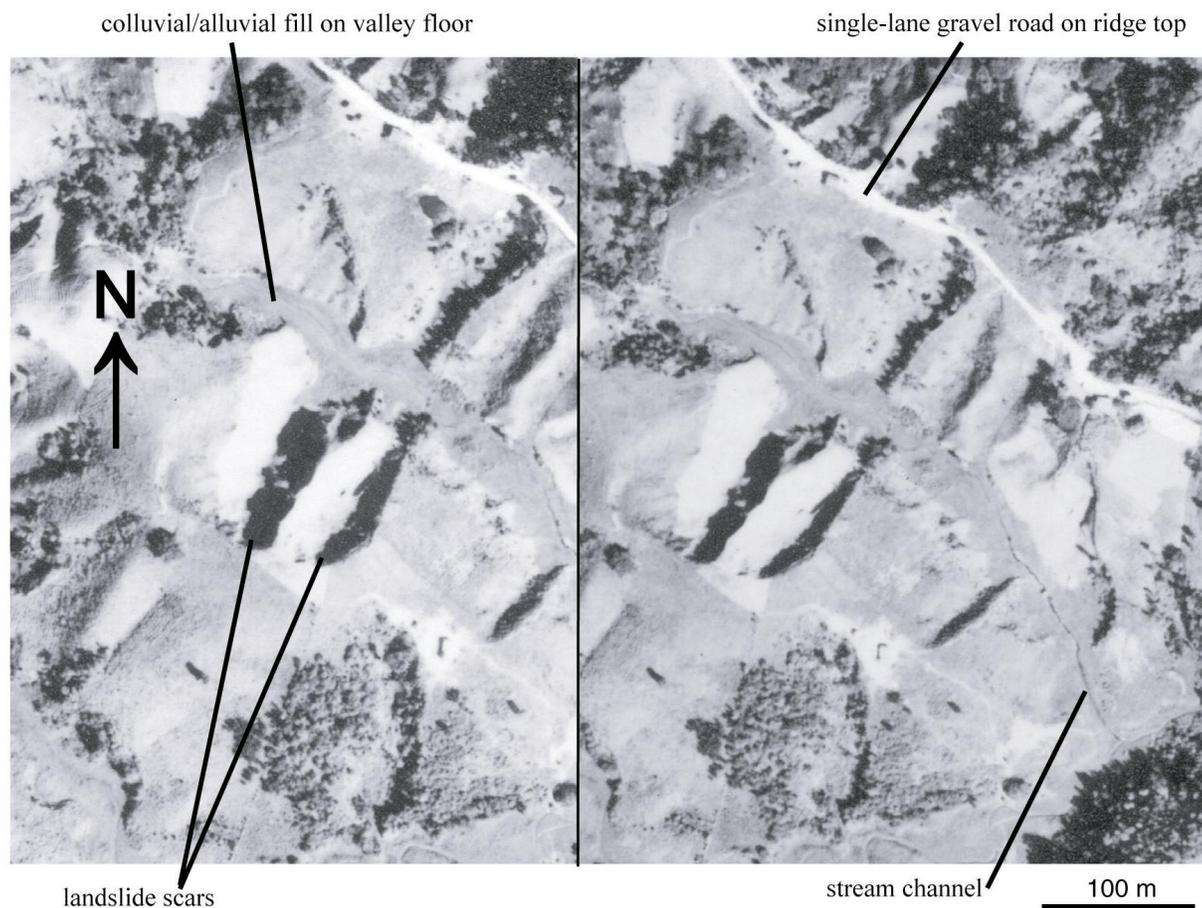
Figure 10. Stereo aerial photographs of southeastern Cayaguás watershed, Puerto Rico, 1951, showing 15 landslide scars of various ages, and sediment stored as colluvial/alluvial fill on valley floor. Sunlight from right (east) side of photographs. Second-order stream flows towards southeast.

Figure 10, which can be viewed in three dimensions with a stereoscope, highlights the abundance of landslide scars and their effect on hillslope morphology and land use. Landslide features dominate most of the hillslopes in the pair of photographs. Farmers have adapted to these conditions by planting plantains or grazing cattle on hillslopes, in spite of the presence of landslide scars. Landsliding, slopewash, and soil creep have shifted much of the nutrient-rich topsoil from the hillslope to the valley bottom. This large-scale, relatively rapid movement of sediment to valley floors which began in the 19th century, seems to have inhibited the pre-disturbance relatively rapid channel development here and elsewhere in the watershed, and has created a boggy, poorly drained substrate. On the colluvium- and alluvium-filled valley floors that result from these processes, farmers raise *Colocasia esculenta*, (malanga) the crop, noted above, that tolerates saturated soil conditions (Fig. 10). The most profound aspect of the rate of mass wasting in this watershed is the total volume of material shifted from hillslopes and moved to footslopes and river channels. This volume, 10.9 million m³, indicates that, on average, the ground surface in this watershed was lowered by 660 mm in approximately 175 years, attesting to the remarkable effectiveness of humans as geomorphic agents (Table 3) [Osterkamp, 2000].
