## Geomorphic effects of large debris flows and flash floods, northern Venezuela, 1999

MATTHEW C. LARSEN and GERALD F. WIECZOREK

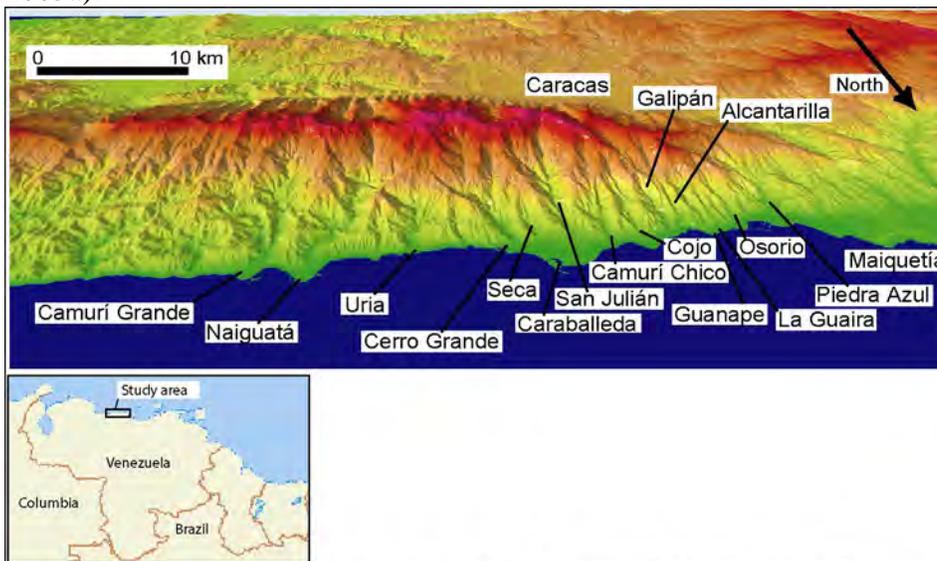
Fig. 1. Oblique view looking south at the Sierra de Avila--coastal mountains, northern Venezuela. This region of steep, highly dissected slopes and narrow coastal plain comprises the state of Vargas. Watershed size is on the order of a few tens of square kilometers and relief is extreme,  $>2,000$  meters. Image courtesy of F. Urbani, Universidad Central de Venezuela.

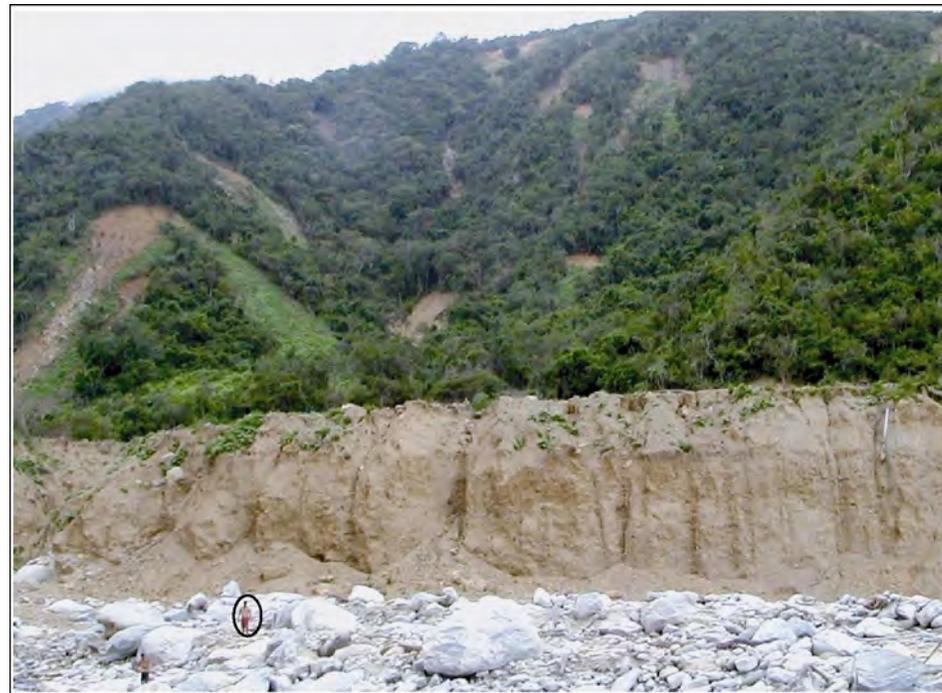
Fig. 2. Prehistoric terrace of flood and debris-flow deposits about 20 m thick above current channel of Quebrada San Julián near Caraballeda. Channel is filled with car-size boulders deposited by December 1999 debris flows and floods. Note person for scale on left side of photograph.

Terraces consisting of prehistoric debris-flow and flood deposits are elevated 10-20 m above the current stream channels, suggesting contemporaneous tectonic uplift of the coastal range combined with channel incision (fig. 2). An arid period associated with the late Pleistocene has been correlated with elevated terraces having similar deposits of bouldery debris over bedrock located about 100 km west of the Vargas region (SCHUBERT 1985). Scouring of channels and removal of alluvium during December 1999 exposed eroded bedrock benches above the apices of the fans, with apparent vertical steps ranging from about 0.5 to 2 m above the current levels of the channels. These benches are

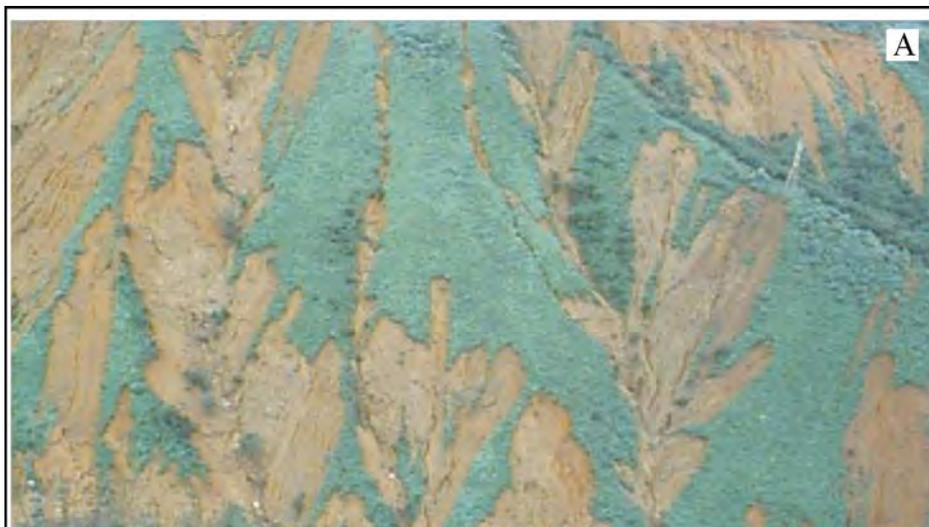
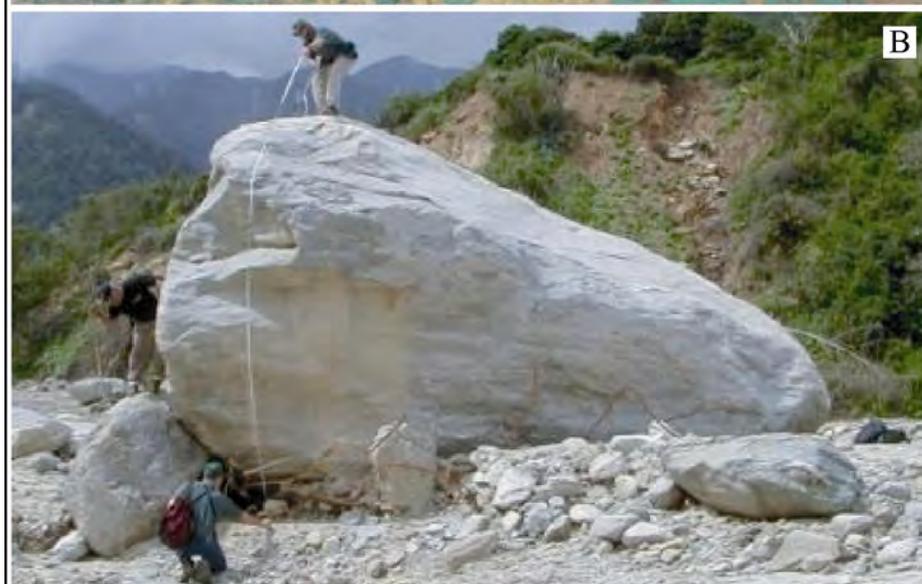
Fig. 3A. Coalescing shallow landslides initiated on steep hillsides in soils developed over bedrock of Tacagua Formation. Shallow slides initiated on steep hillslopes coalesced with other slides as they traveled into channels. Transmission tower, 30 m high, (upper right) for scale. 3B. Large (11.3 x 5.0 x 3.5 m) sub-rounded gneissic boulder deposited in center of channel of Quebrada Camurí Chiquito. Boulder was deposited atop former house foundation; strands of steel rebar are visible along base of boulder.

Landslides were abundant and widespread on steep slopes within areas underlain by schist and gneiss, from near the coast to slightly over the crest of the Sierra de Avila. Some hillsides were entirely denuded by single or coalescing failures (fig. 3A). Most landslides were initiated as thin earth (soil) slides or debris slides (soil with pieces of rock), as indicated by shallow sliding surfaces within soil or weathered, foliated, and jointed rock (classification according to VARNES, 1978). With the addition of more water from either the hillslopes or the channels, these slides of loose soil and rock liquefied into debris flows. A few isolated larger rock slides, and rotational or block slides of earth or rock, also were observed. In most cases, debris-flows entrained additional colluvium while traveling down steep hillside paths. Upon entering main channels, the debris flows incorporated stream alluvium from the channel and colluvium from channel banks, ranging in size from fine-grained material to extremely large boulders (fig. 3B).

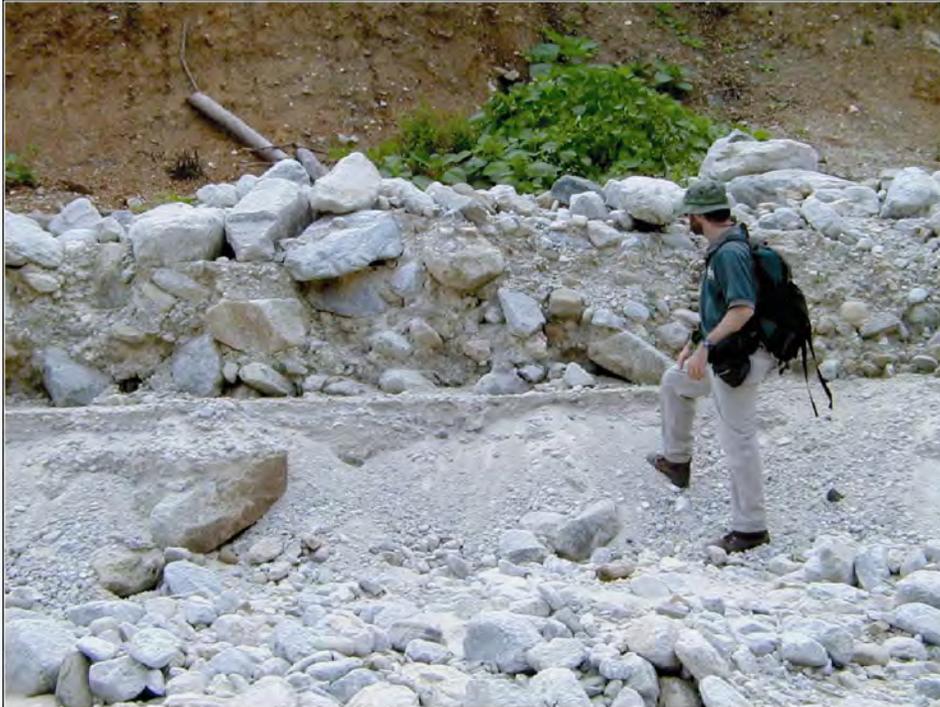
Fig. 4. Remnant of 1999 bouldery debris-flow deposit (~ 2 m thick) incised by later flooding with subsequent fine-grained flood deposits in foreground in the channel of Río Camurí Chiquito. Grain-to-grain, partially matrix-supported randomly oriented boulders indicative of transitional flow (KEATON et al. 1988).

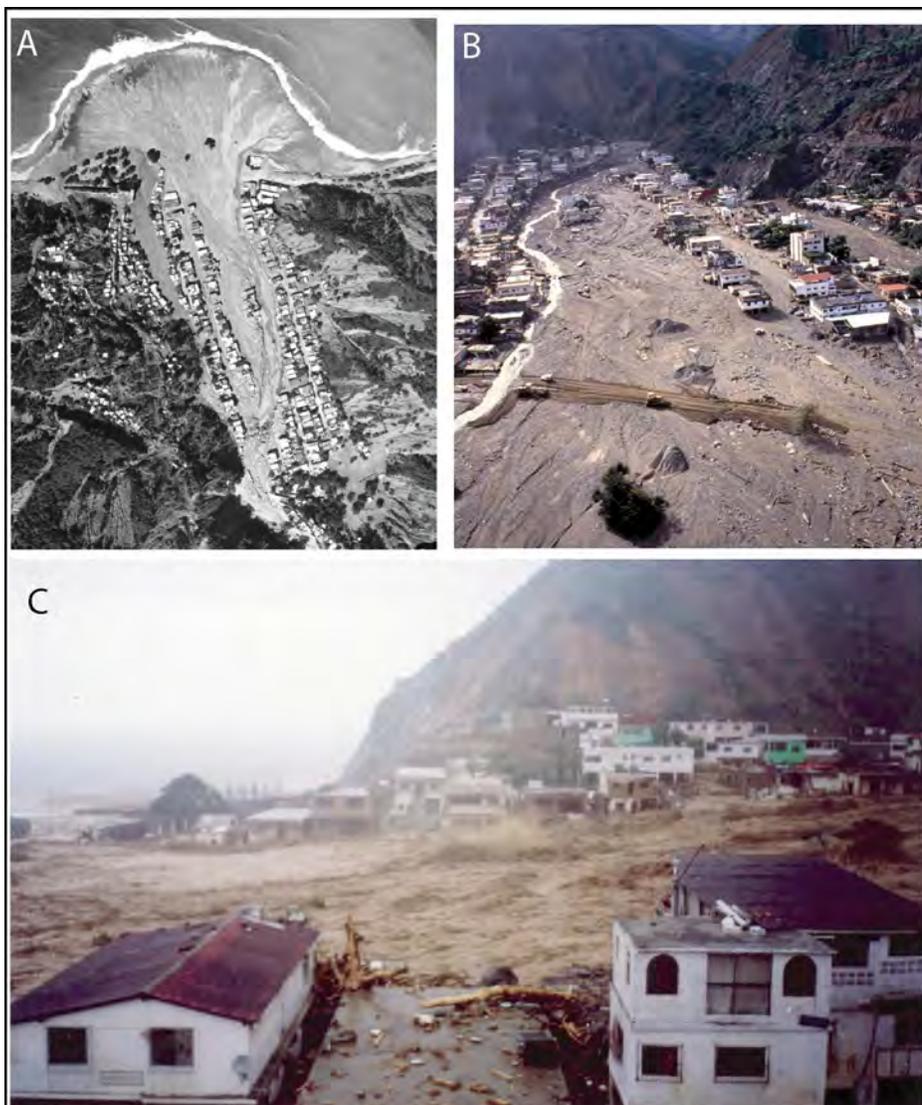
Fig. 5A. Aerial photograph showing Uria alluvial fan progradation seaward and extensive areas of destroyed housing and landslide scars on adjacent hillslopes, December 1999. 5B. Oblique aerial view to south showing Uria alluvial fan during initial road-rebuilding effort, January 2000. 5C. Photograph taken by resident, Emilio Peñaranda, during floods of December 16, 1999, view to east [courtesy of Prof. José Luis López, Universidad Central de Venezuela]. Prior to the 1999 storm, the flooded area in the center of the fan was occupied by 2-story homes such as those in the foreground.

from the coast (fig. 5A, 5B). Additionally, the deposition extended laterally beyond the shorelines as subaqueous fans for some tens of meters (LARSEN et al. 2001, LÓPEZ et al. 2003b). Shorelines of some alluvial fans prograded by more than 100 m (LÓPEZ et al. 2003a,b, BELLO et al. 2003). The thickness of subaqueous deposition from the 1999 event could not be determined because of the lack of pre-event bathymetric surveys. The subaqueous deposits were probably less than 1m thick, reasoned from observations of subaerial, thin-bedded, dominantly fine-grained deposits grading into the coast. Most of the fine-grained deposits examined at the coastline were of fluvial origin. Sediment-laden flood flows that are the likely source of some of these deposits were observed by residents on the

morning of December 16, 1999 (fig. 5C). BELLO et al. (2003) estimate that Cerro Grande River flood flows had an average sediment concentration of 35-40% by volume. Maximum debris-flow discharges for the Cerro Grande and Uria Rivers were estimated at 1,230 m<sup>3</sup>/s and 1,670 m<sup>3</sup>/s, respectively, by LÓPEZ et al. (2003a). NAKAGAWA et al. (2003) reported peak debris-flow discharge of 900 m<sup>3</sup>/s for the Camuri Grande River, with maximum sediment concentration of 65% by volume. A characterization of the type(s), sequence and thickness of deposition, and maximum boulder size within each drainage and on fans is given in Table 1.

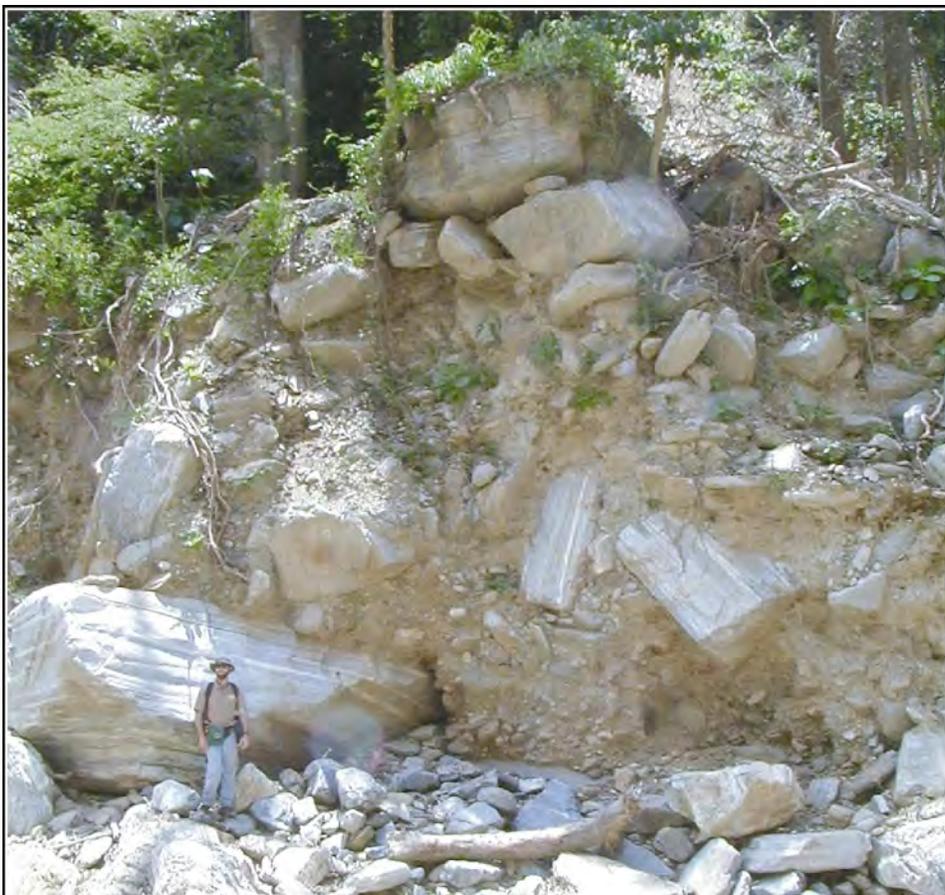
Fig. 6. Prehistoric debris-flow deposit (7.7 m thick) undermined in channel bank of Quebrada San José de Galipán. Fully matrix-supported texture with randomly oriented sub-angular large gneissic boulders from the Peña de Mora Formation gneiss deposited in a sandy matrix. Top of deposit, which is matrix-free, produced by winnowing of debris flow by recessional and/or secondary overland water flows.

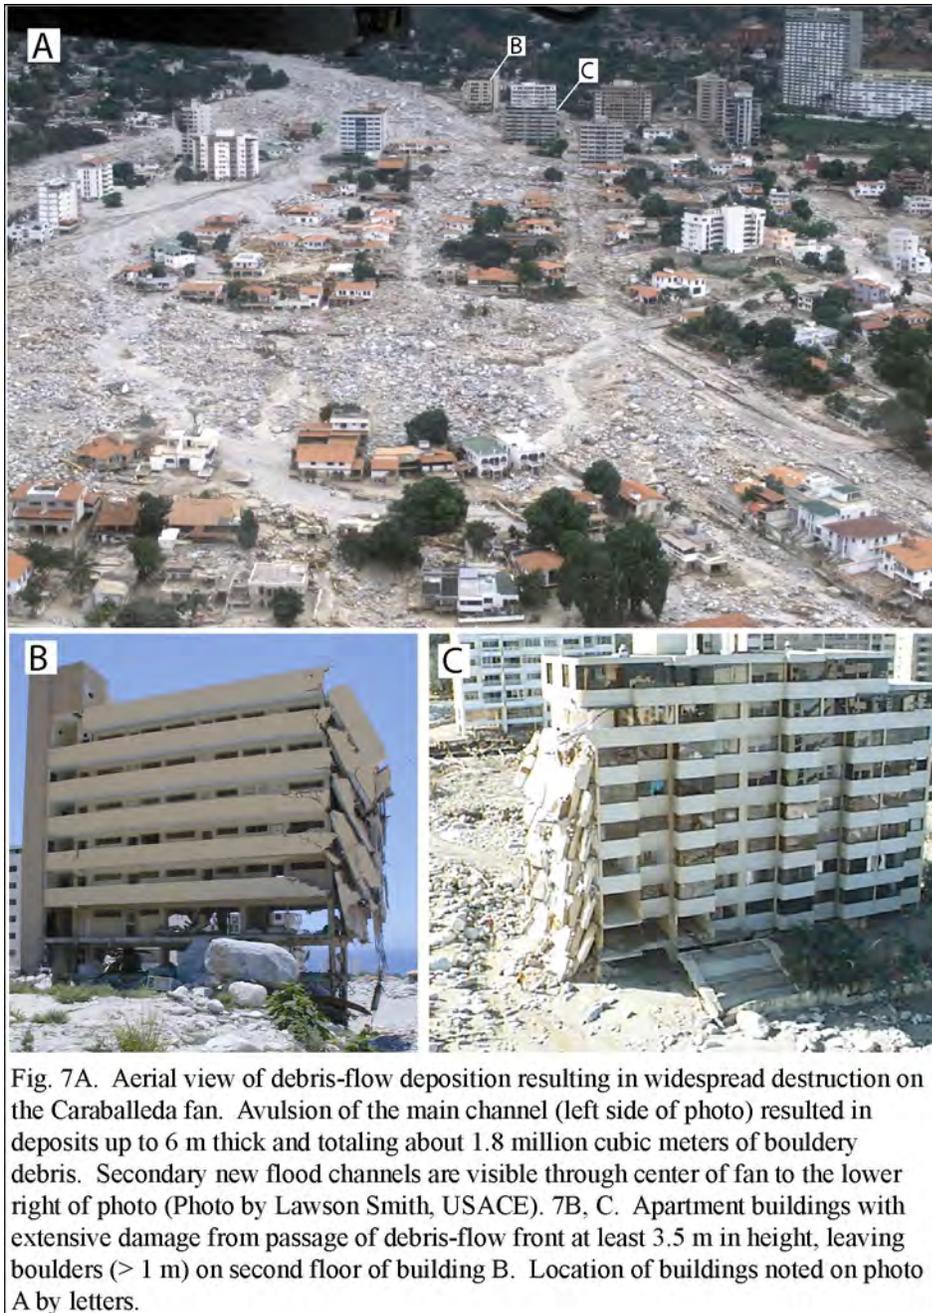
Fig. 7A. Aerial view of debris-flow deposition resulting in widespread destruction on the Caraballeda fan. Avulsion of the main channel (left side of photo) resulted in deposits up to 6 m thick and totaling about 1.8 million cubic meters of bouldery debris. Secondary new flood channels are visible through center of fan to the lower right of photo (Photo by Lawson Smith, USACE). 7B, C. Apartment buildings with extensive damage from passage of debris-flow front at least 3.5 m in height, leaving boulders (> 1 m) on second floor of building B. Location of buildings noted on photo A by letters.

The large fan of the San Julián River at Caraballeda was one of the areas most heavily damaged in December 1999 (fig. 7). The volume and thickness of deposition, maximum size of transported boulders, and size of inundated area were all notably larger in this drainage than in other watersheds (Table 2). The Caraballeda fan was one of the more intensively developed communities with many high-rise buildings and large individual multi-story houses. At the fan apex, the peak volume of flow, probably during a debris-flow surge, exceeded the channel capacity. As a result, multiple stream avulsions and subsequent flows spread bouldery debris throughout the community. The flow

ere near the middle of the fan where 2-story houses were either completely destroyed or partially buried (fig. 7A). At this locale, the fan slopes ranged between 5 and 6 degrees, and the maximum thickness of deposits was 5.3 m, as determined by comparing pre- and post- topography.

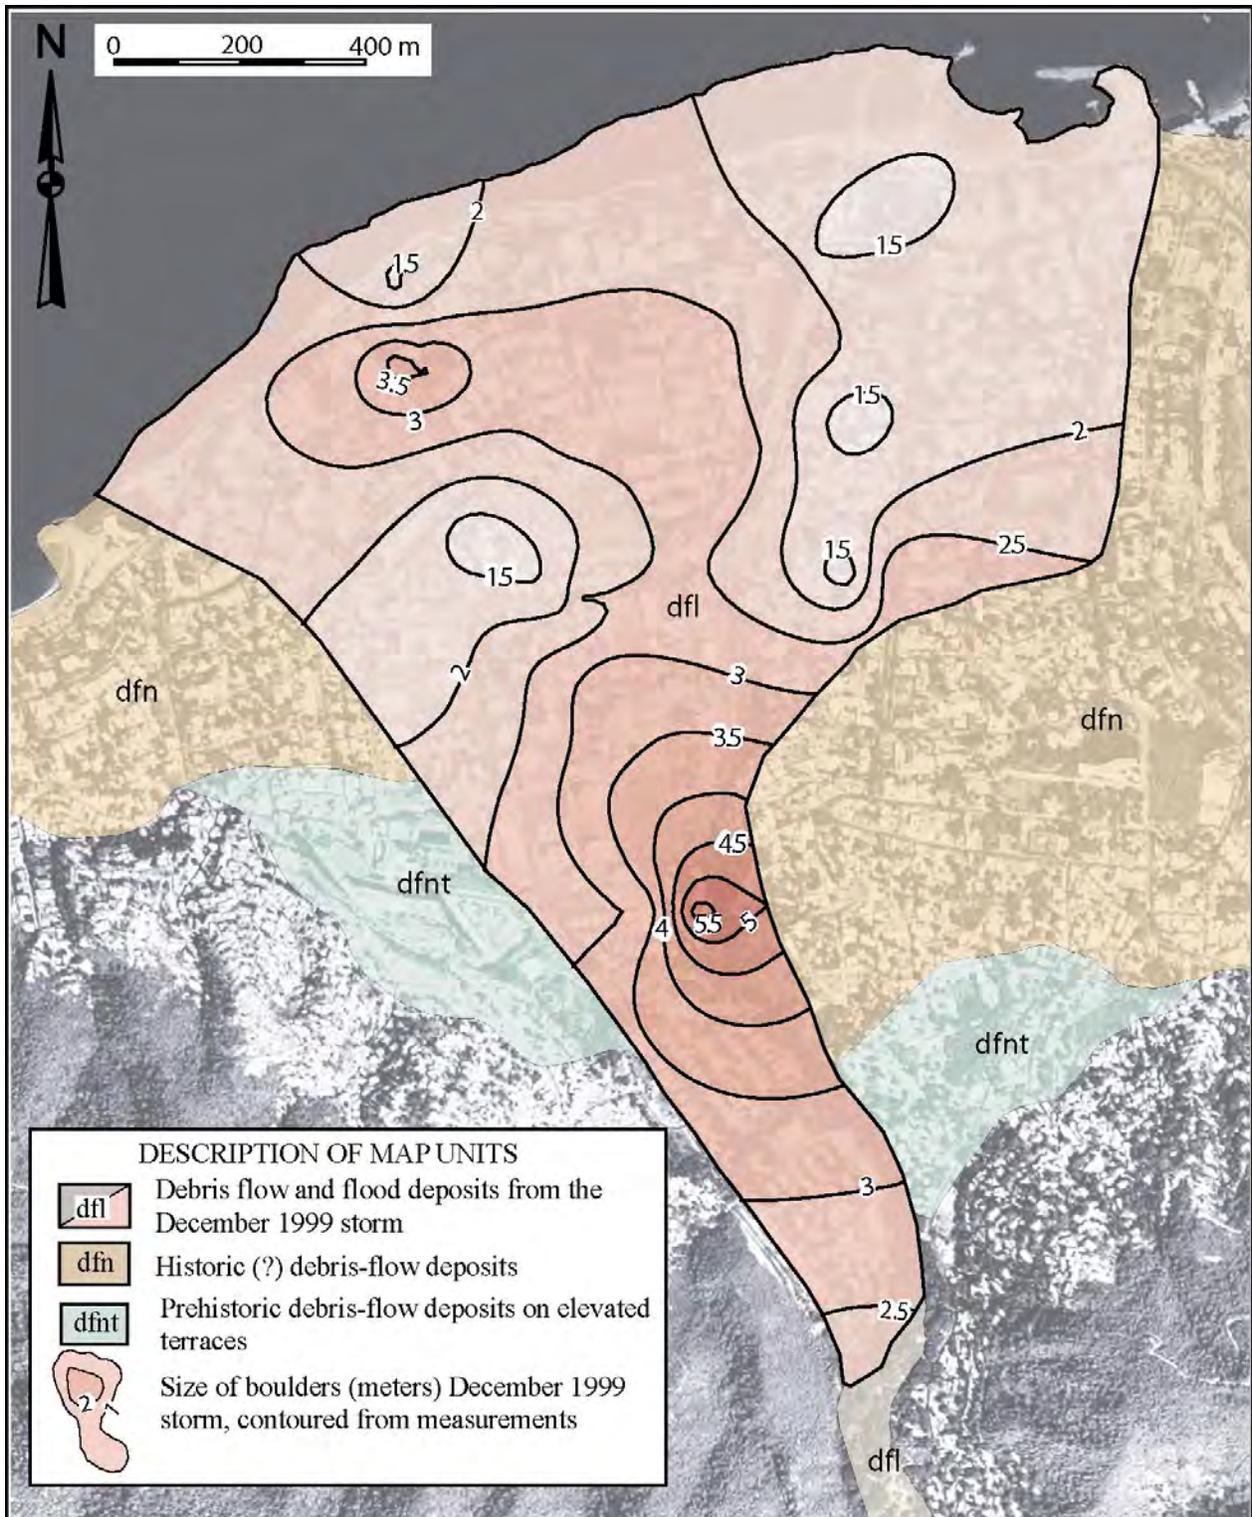
Fig. 8. Debris-flow deposits and contours of maximum boulder size on the Caraballeda Fan, Venezuela, simplified from WIECZOREK et al., (2002).

We measured degree of slope, depositional thickness, and boulder size from the fan apex to the distal edge of the fan near the coastline (fig. 8, see also WIECZOREK et al. 2002, Appendix B). We mapped the distribution and thickness of deposits and estimated the total volume of deposits on the fan (fig. 9). Total deposition on the subaerial fan was calculated using two different methods. In the field we measured deposit thickness, or if necessary, estimated the depth of flow where material had been removed from cleanup. Where material had been removed, mudlines on houses and other structures were used as an approximate measure of deposit thickness. Total

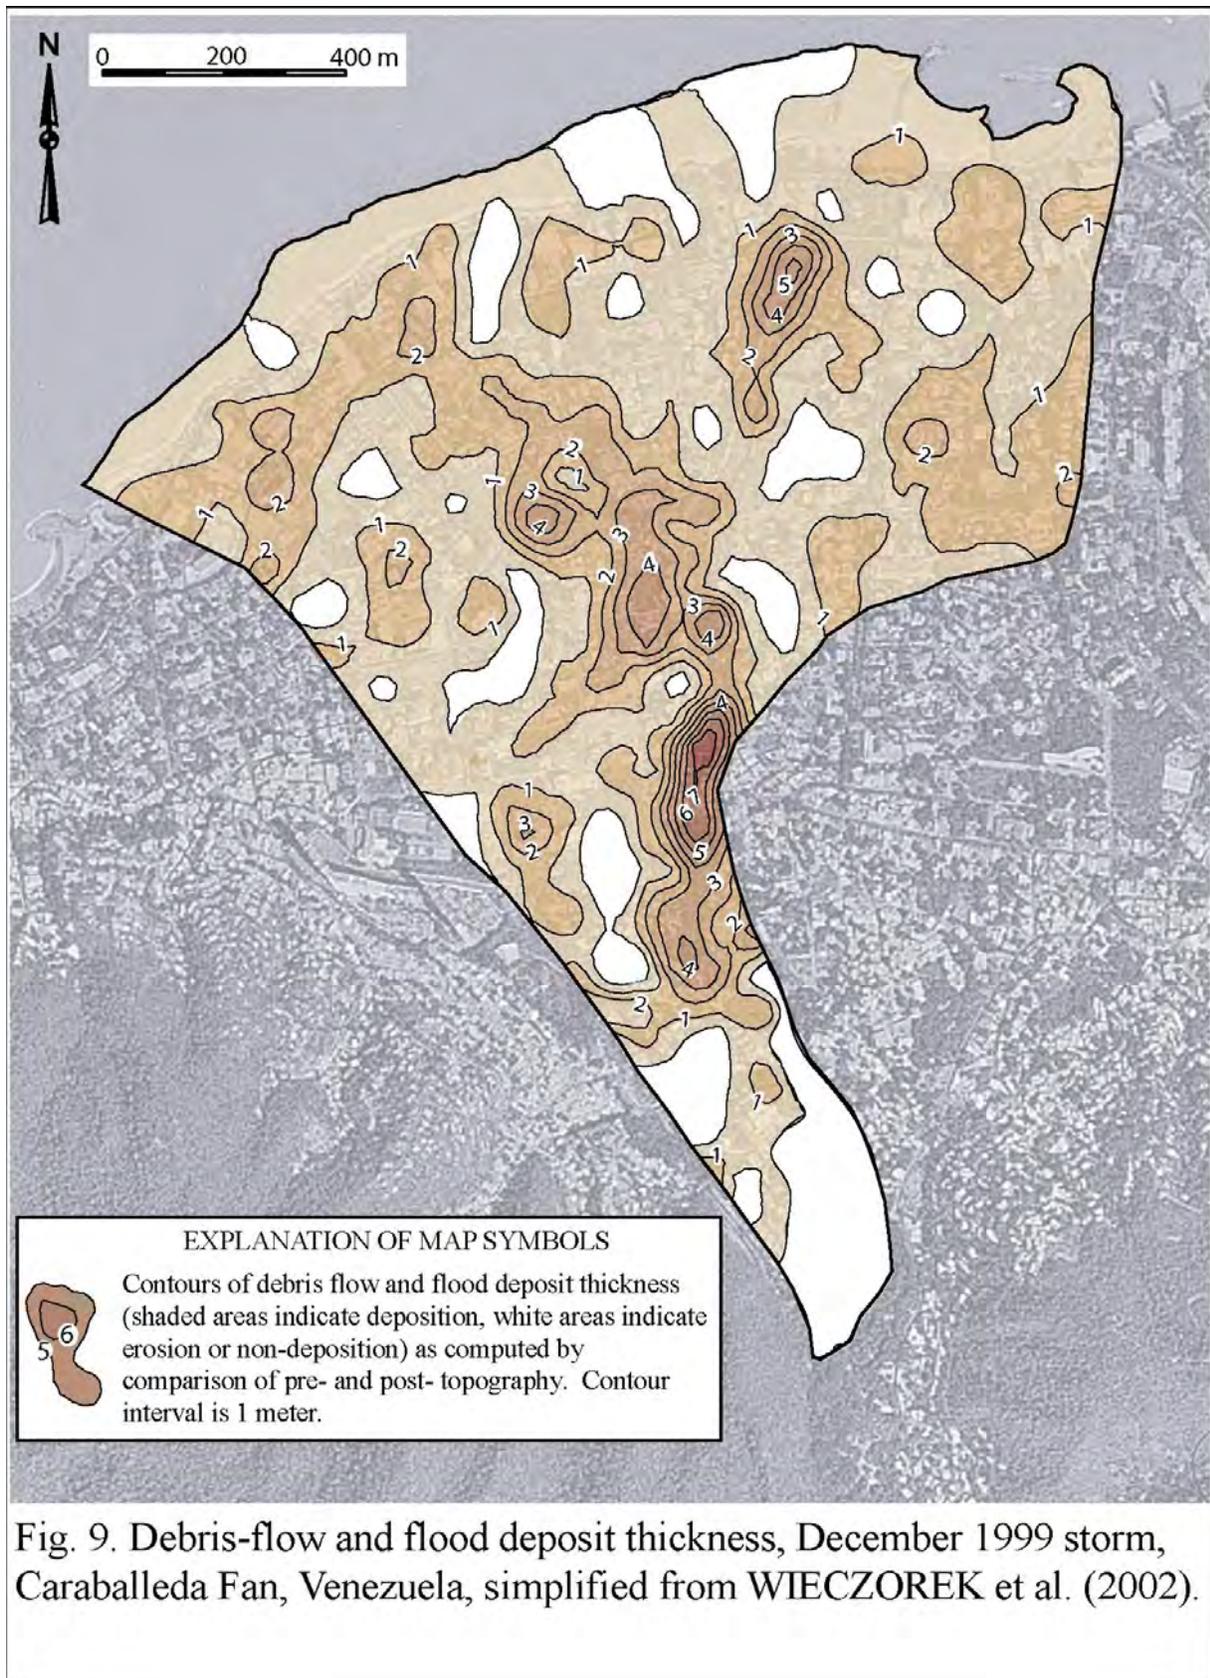
Fig. 9. Debris-flow and flood deposit thickness, December 1999 storm, Caraballeda Fan, Venezuela, simplified from WIECZOREK et al. (2002).

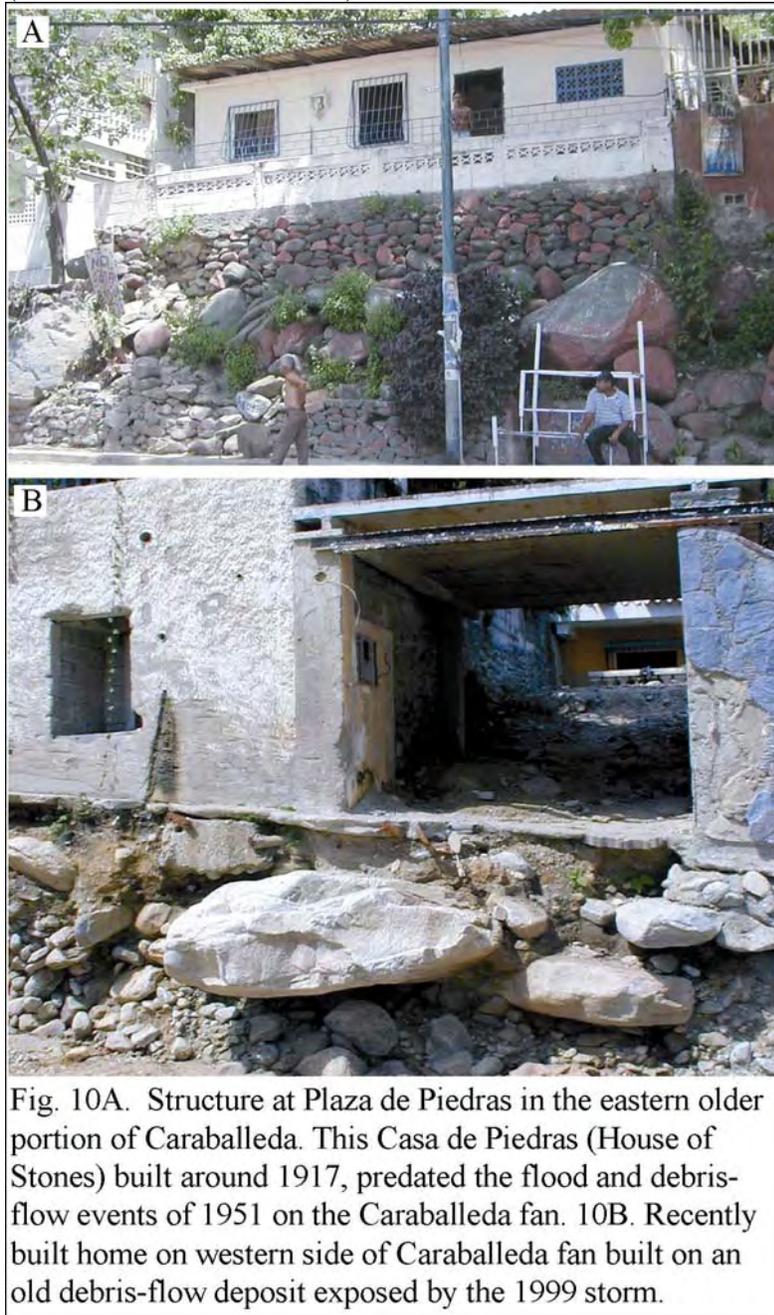
Fig. 10A. Structure at Plaza de Piedras in the eastern older portion of Caraballeda. This Casa de Piedras (House of Stones) built around 1917, predated the flood and debris-flow events of 1951 on the Caraballeda fan. 10B. Recently built home on western side of Caraballeda fan built on an old debris-flow deposit exposed by the 1999 storm.

old debris-flow deposit exposed by the 1999 storm, provides an additional example of the extensive debris-flow deposits and vulnerability of structures built on this fan (fig.10B). In a fresh exposure located on the western channel banks, we found organic carbon in paleosols above and below a thick (10-m) debris-flow deposit, containing large subrounded gneissic boulders (diameters of 2-3 m) suspended in a sandy matrix. The dates from the carbon samples recovered from the paleosols bracketed the debris-flow deposit between the upper dates of 3720 +/- 50 yBP, 3750 +/- 40 yBP and the lower date of 4267 +/- 38 yBP. Closer examination of this exposure and mapping the lateral extent of this deposit might determine whether this sequence of coarse bouldery deposits represents a single episode or several different debris-flow episodes within the span of about 500 years. Although we observed prehistoric debris-flow deposits in other watersheds, we did not explore systematically for dateable materials to bracket their ages.
